SUBJECT: A Mechanic Died When Crushed by the Lift Bed of a Trash Roll-off Truck

SUMMARY
California FACE Report #05CA008

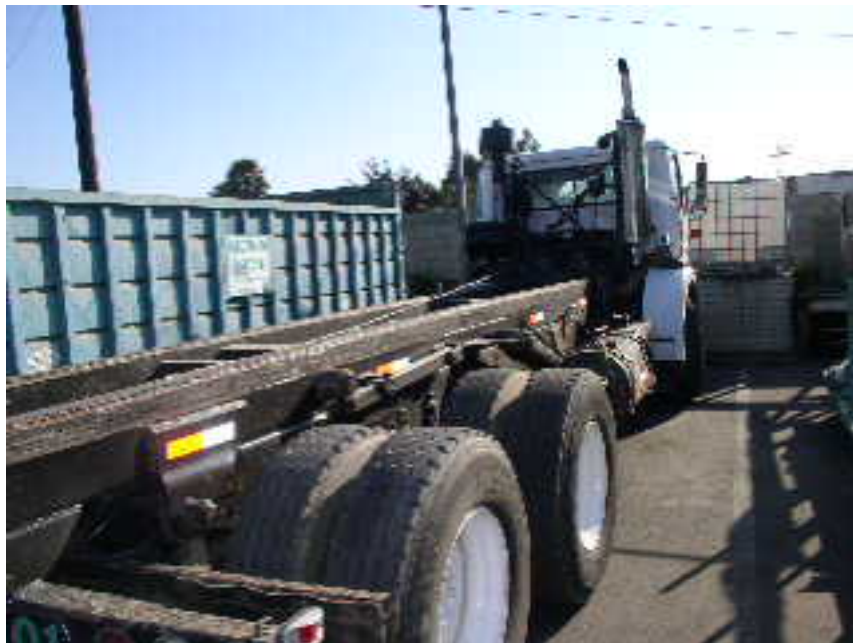
Exhibit 1: A picture of a roll-off truck similar to the one involved in the incident.

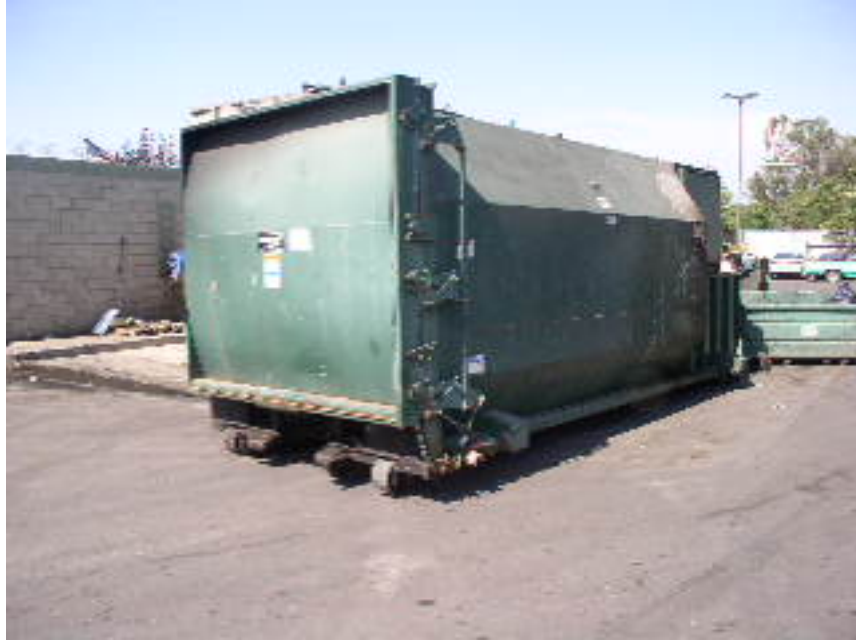
On the day of the incident, the victim was working the day shift and was alone in the shop. A driver brought his truck into the shop because he was having problems with the hydraulic system. The truck had on its bed an empty compaction system container (Exhibit 2). The driver drove his truck, with the container on it, into one of the shop's service bays, and then raised the bed of the truck. According to the other mechanics, there was a routine that most mechanics followed when working on trucks. Usually, the mechanic, not the truck driver, would bring the truck into the service bay and raise the truck bed and then place the safety device that holds the truck bed in a raised position in its proper place.

Exhibit 2: A picture of a container similar to the one that was on the truck when the incident occurred.

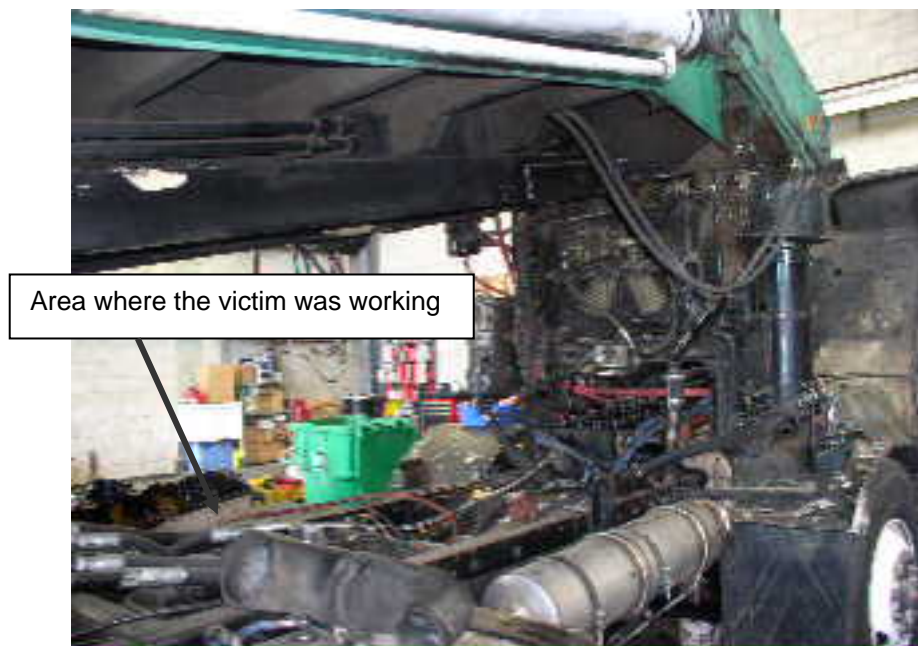
Exhibit 3: A picture of a roll-off trash truck with the bed in the raised position looking rear to front.

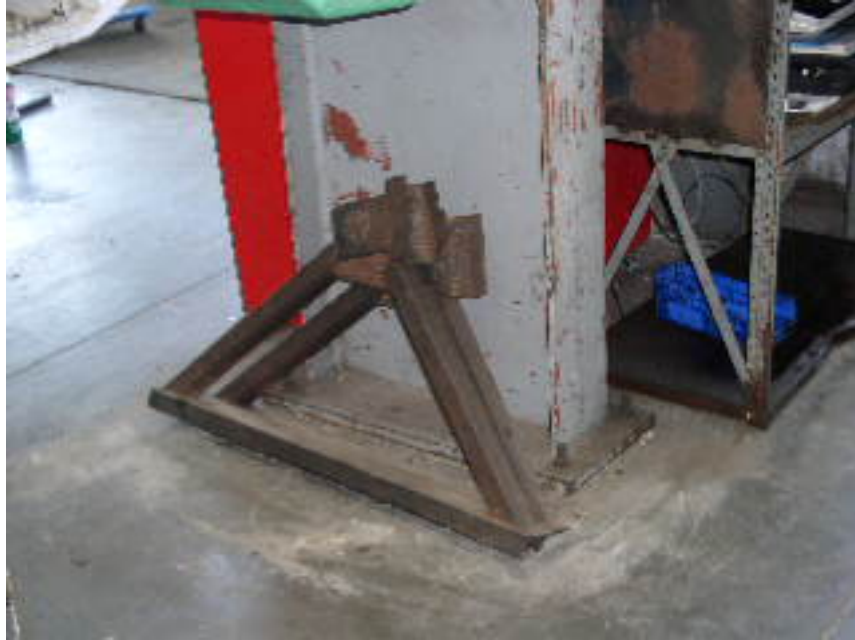
The site of the incident was a maintenance and repair shop for a waste collection and recycling company. Most of the equipment mechanics worked the swing shift in order to perform the maintenance and repairs to the trucks that were parked overnight. The day shift usually had one or two equipment mechanics working in order to cover any road or shop emergency that may develop. The truck involved in the incident was a roll-off truck used to pick up, drop off, and haul large containers of waste and recyclable trash (Exhibit 1). The truck bed consisted of two long steel rails hinged at the rear of the truck frame and a hydraulic system capable of raising and lowering the truck bed with a designated load. This particular model of truck did not come equipped with safety devices installed to hold the bed in a raised position, so a portable or external type of safety jack stand was needed in between the bed and frame of the truck when the bed was in a raised position. The safety jack stand made available for these trucks was triangular in shape and fitted firmly between the truck frame and truck bed when the bed was in the raised position (Exhibit 4).

Discussion: The roll-off trash truck involved in this incident was not equipped with a safety bar to hold the bed of the truck in a raised position. Safety jack stands were readily available for use in the shop. The safety jack stands were leaning against the wall of the service bay the truck was in. Neither the driver nor the victim placed the safety jack stands in place after the bed of the truck was raised. The company policy stated that the safety jack stands were to be used whenever the truck bed was raised for the purpose of maintenance or repair. Most work routines and patterns are designed to ensure all the necessary steps are being followed when performing certain procedures. Whenever work routines or patterns are disrupted, there is a chance that something might get omitted. In this case, the work routine that was usually followed when a truck is to be serviced or repaired was not followed. The driver, instead of the mechanic, drove the truck into the service bay and then raised the bed of the truck. When a mechanic performs this task, the next step in the routine would be to put into place the safety device that would hold the bed of the truck in a raised position. Supporting elevated objects with jack stands or cribbing ensures stability of the object, especially when work has to be performed under the object. Had the truck been equipped with a bed lock or the safety jack stands been put in place, this incident might have been prevented.

Exhibit 4: A picture of the safety jack stands used to support the bed of a roll-off trash truck in the raised position.

Recommendation #1: Ensure lift beds of trucks are properly supported before performing maintenance or repairs.
